Derby City Council

**Royal Halal Meat & Bakery, 2-4 Pear Tree Road, Normanton, Derby, DE23 6PY**  
**Date of Inspection: 13 January 2025**

**Schedule C – Photographs of Royal Halal Meat & Bakery, 2-4 Pear Tree Road, Normanton, Derby, DE23 6PY**

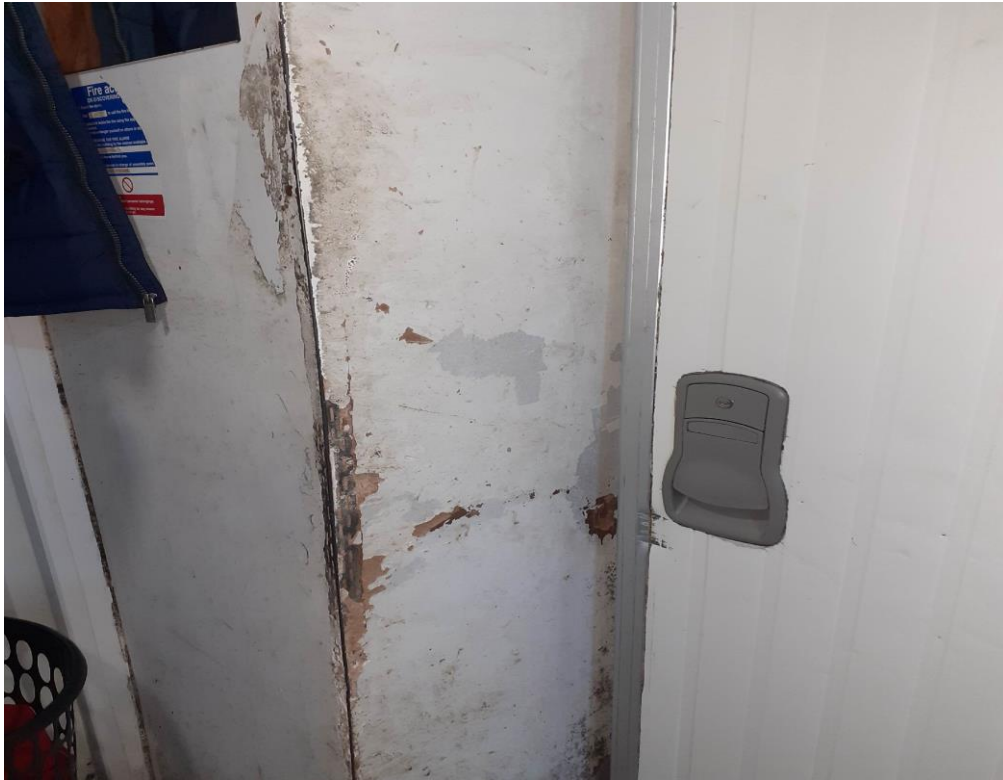
The wall was damaged next to the walk in chiller in the rear preparation room.

9. There was some damage to the wall in the rear preparation room near the walk in chiller. Repair the wall surface to leave it in a sound easy to clean condition.

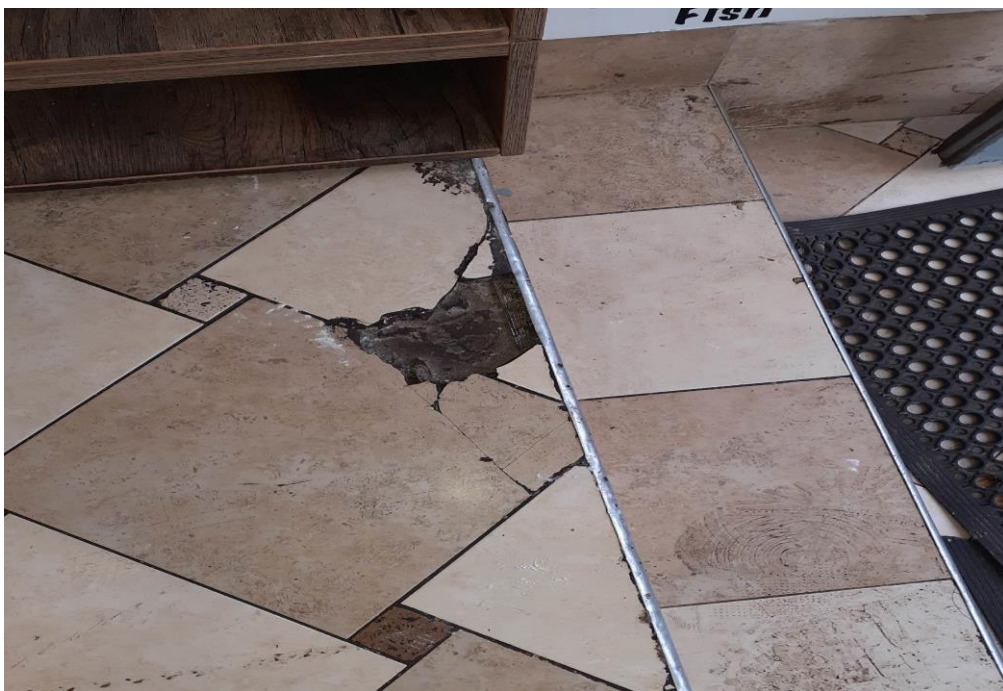
A floor tile was damaged in the shop near the flour room.

7. There was damage to a floor tile in the shop near the butcher's counter in front of the flour room entrance. Replace the tile.

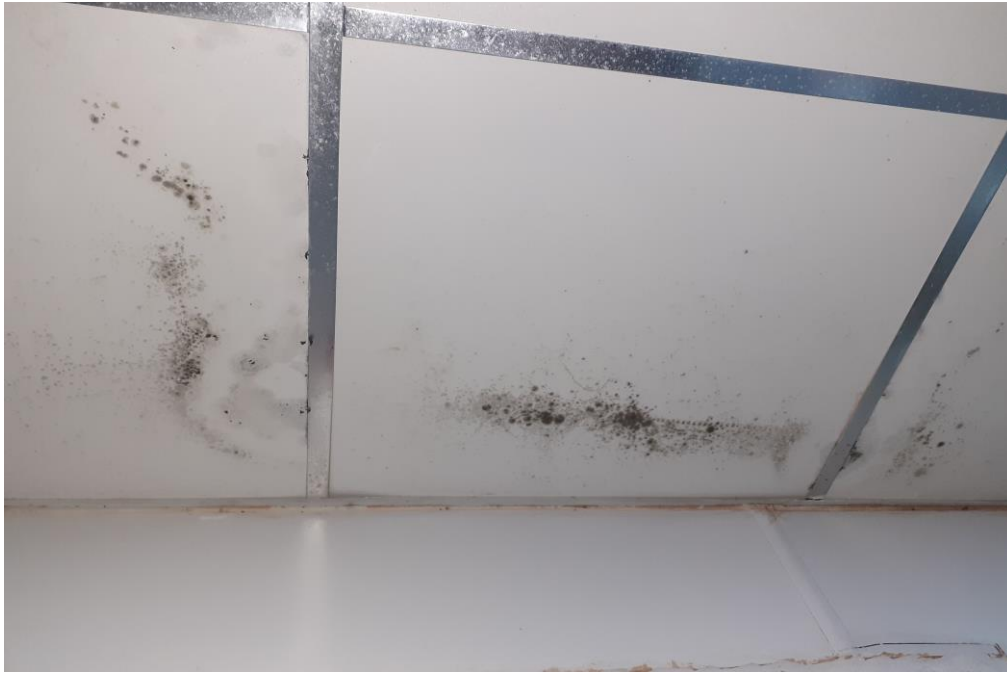
The ceiling was mouldy in front of the walk-in chiller in the rear preparation room.

- The wall/floor junctions left hand side of the stainless steel table were dirty.
- There was mould on the ceiling in front of the walk in chiller.
- The wall/floor junctions behind the double sink were dirty.
- The wall under the double sink was dirty.

This area must be thoroughly cleaned and maintained in a clean condition.

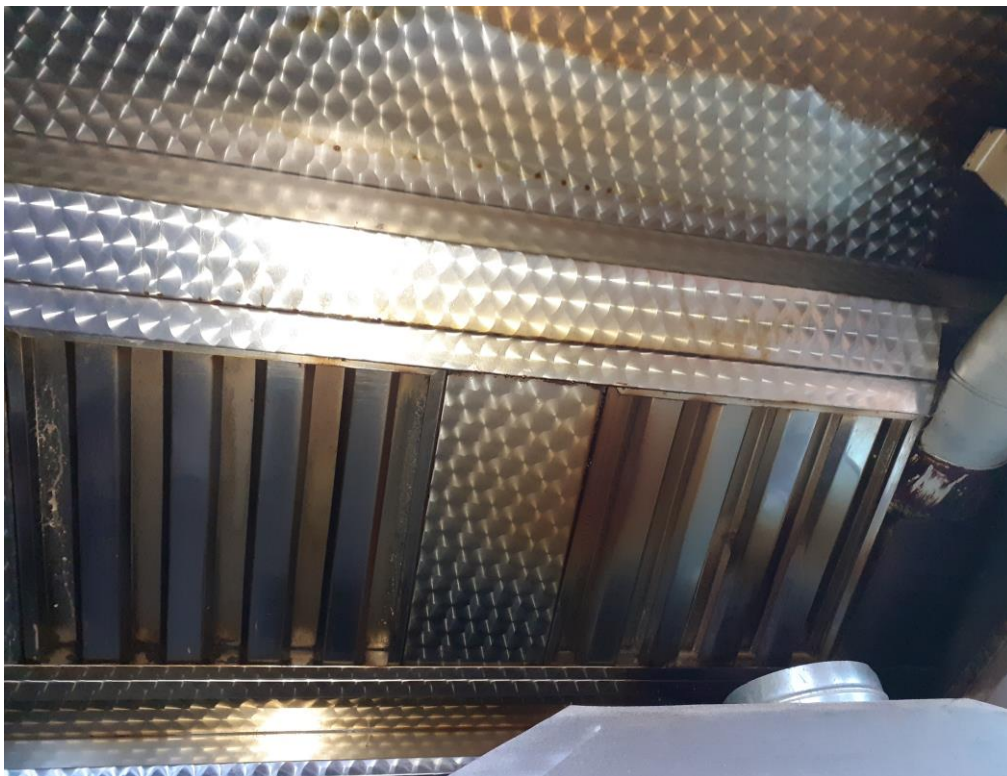
The filters in the ventilation canopy in the bakery area were dirty.

- The wall/floor junctions under the stainless steel table were dirty.
- The filters in the ventilation canopy were dirty.
- The wall/floor junctions behind the rotisserie cooker were dirty.

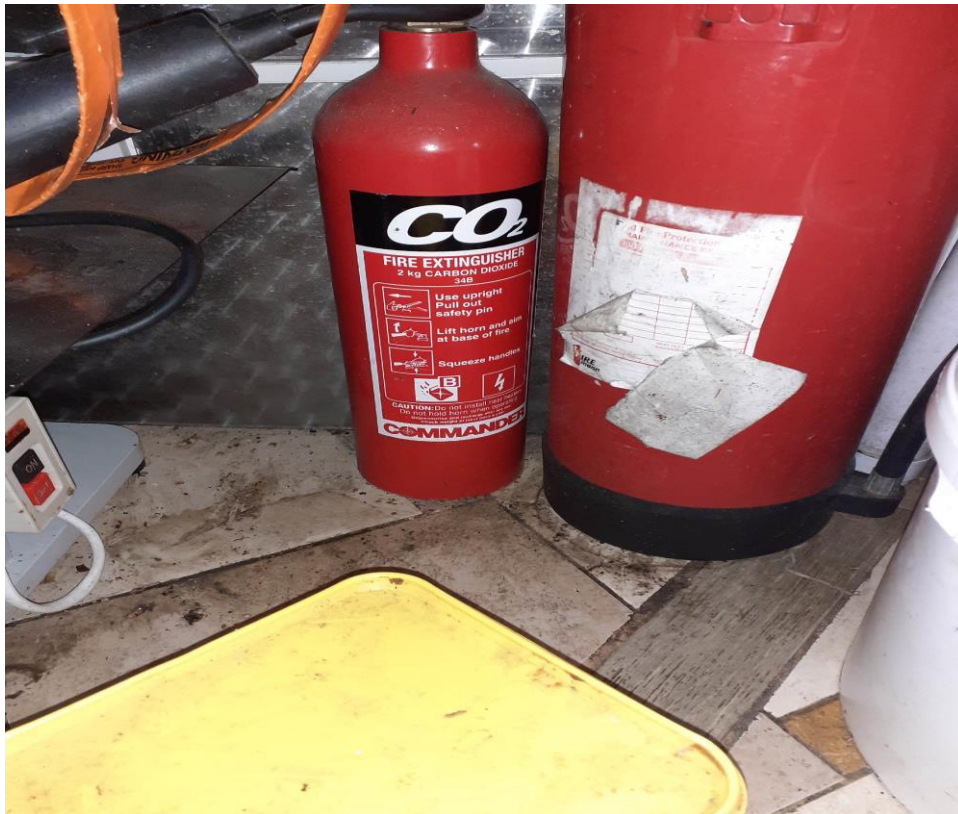
The floor under the sink in the raw area dirty.

- The wall/floor junctions to the right hand side of the mincing table was dirty.
- The floor under the sink was dirty.
- The floor to the right hand side of the meat counter was dirty.

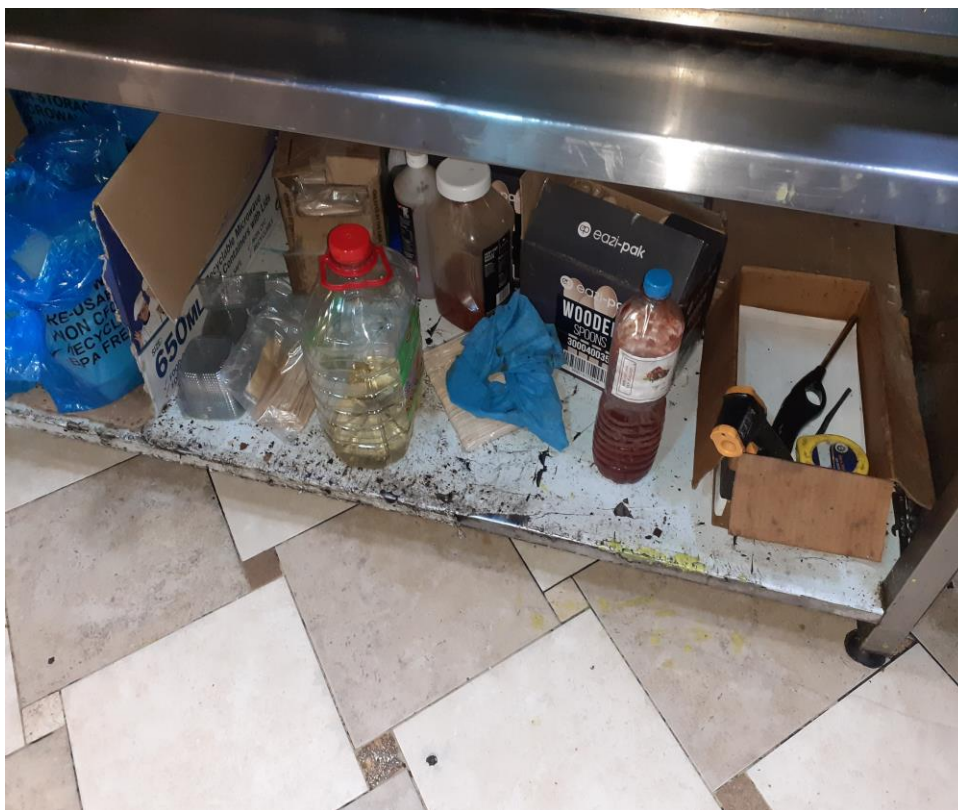
Plastic sheeting on the shelf under the griddle in the bakery area.

8. There were still portions of the protective plastic coating covering the shelf under the griddle in the bakery section. This plastic is put onto to prevent damage to the steel when fitting and is not intended to be left on. This plastic covering must be removed to enable adequate cleaning of the areas affected and to prevent pieces of the plastic finding their way into food.

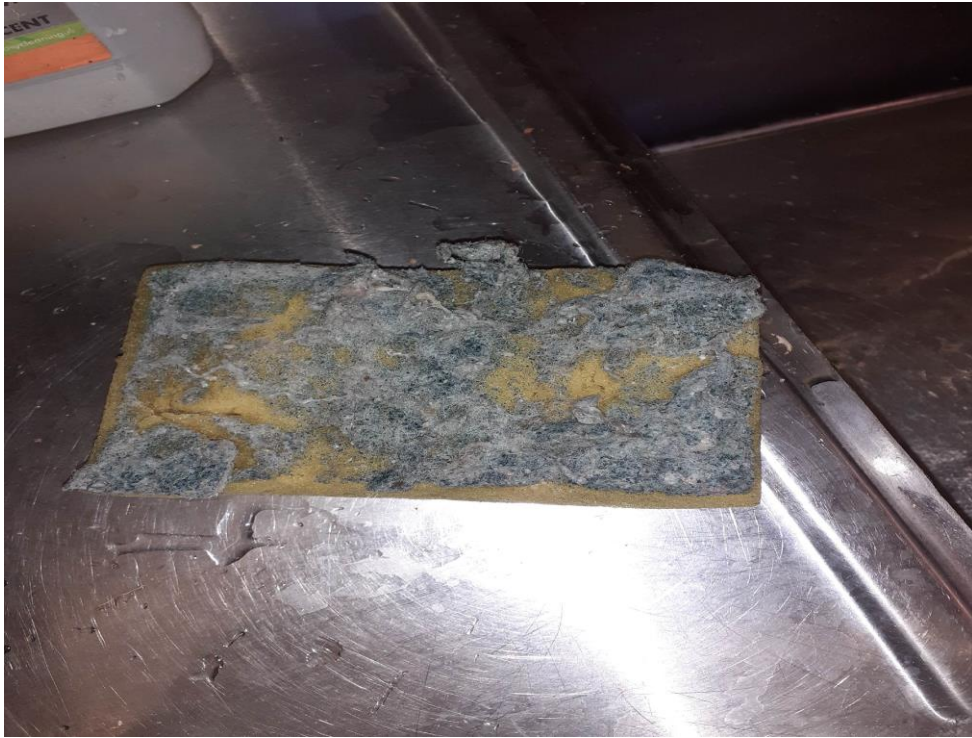
The sponge in the raw area in a worn condition.

which was in a poor condition. In its current state it poses a risk of contamination. Replace these items on a regular basis to minimise the risk of contamination.
